Aster Group

Living (Green) Roofs Review

Final Report

February 2024

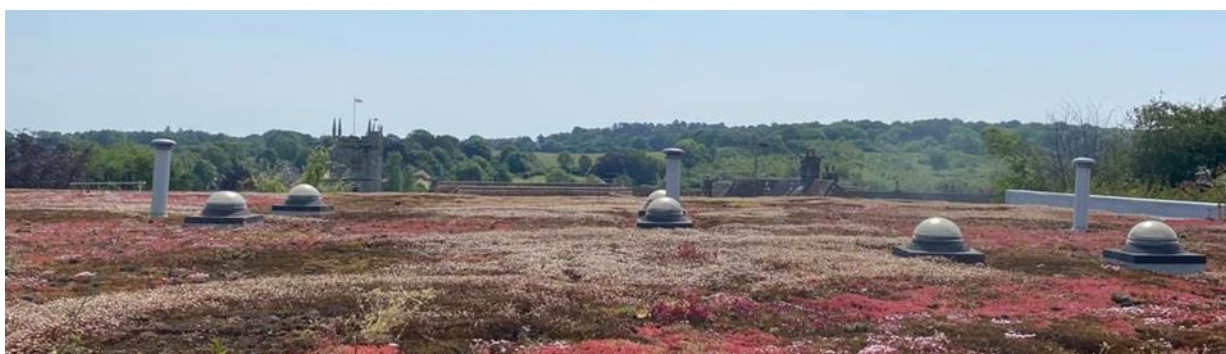
Fig 1

- Roman Barns where all roofs appear to be failing to different degrees.
 - Cyril Wood Court there are light tubes penetrating the roof (see figure 1 below), the seals had perished over time. These were replaced and there were no further reported issues.

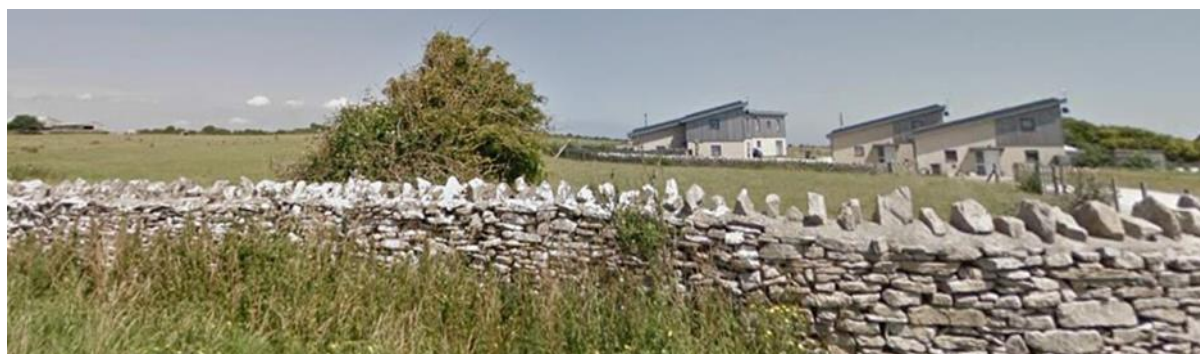
Fig 2

- 4.9 Designed to be a PAS4 scheme the living roofs are mono pitch in an extremely exposed position facing the sea (see figure 2 below):

- 4.10 Whilst pitched roofs are acceptable, in exposed positions, particularly in coastal regions, they are to be treated with caution. The combination of pitched roofs and exposed coastal location made Roman Barns particularly vulnerable to the weather.
- 4.11 Although far from an ideal location for living roofs, there is no reason why they should not be used providing the design, substrate and fixing are appropriate. Due to the slope, rainwater will travel down towards the roof edges more quickly, which can cause the greenery at the top of the roof to dry out, making maintenance or irrigation essential.
- 4.12 Our first consideration was therefore whether Roman Barns were specified and constructed correctly.

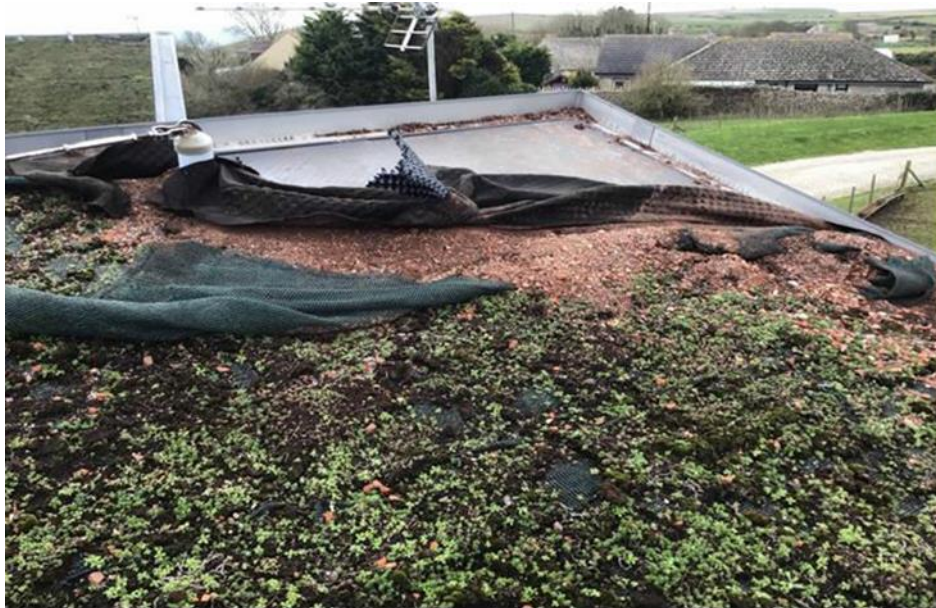
Fig 3

7.3 The initial complaint was made on the 22nd of February 2022 and logged as a temporary repair on a 20-day turnaround (as per policy) Complaint shown below in Fig 3.

Our roof has been damaged in the storm today. Parts of some of the layers have blown off and you can see the felt has come off though still attached.

The photos show the felt, the last photo shows a part of the layer that has blown across the field.

There is no water coming in but I am concerned that more will blow off as flapping badly in the wind. Also the Wood under the roof layers could get water damaged.
